Derived Channel multipleX

Field Trouble Shooting Manual

DCX Systems Inc.
2360 Maryland Road
Willow Grove, PA 19090

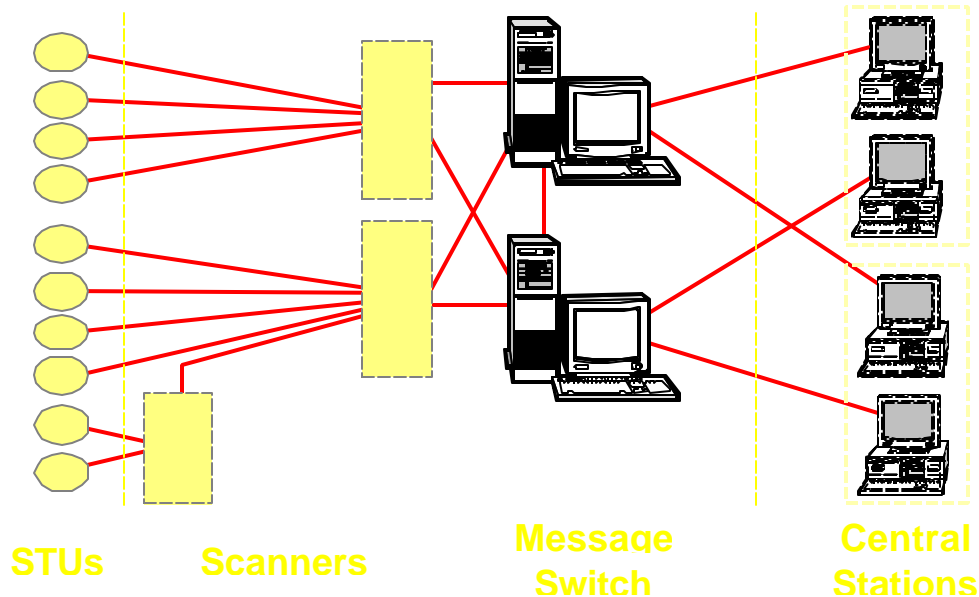
Figure 1

The RScanner is an optional component in the network which is used as an extension to the Scanner. Many telco central offices are small and do not require the STU capacity of a full Scanner. An RScanner is ideal for these locations. It is much smaller and less expensive, with a capability of handling 1 to 96 STUs. However, it is not a stand-alone unit. It must be linked to a Scanner at a remote location (another central office) by means of dual two-wire data lines and a special plug-in card for the Scanner.

The telcos' use of a mix of large Scanners and small RScanners is transparent to the alarm central monitoring station.

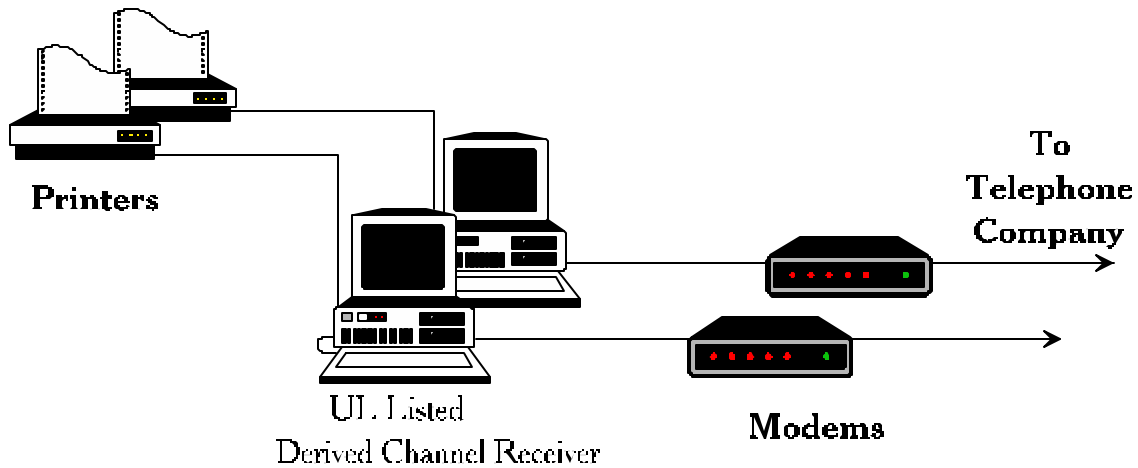
Typical Central Station or Remote Station Monitoring Configuration

Refer to Figure 2 for a diagram of the equipment required in the alarm central monitoring station for a redundant configuration. Connection to the Message Switch is by way of two (2) private data circuits provided by the telephone company. These circuits appear to the alarm dealer as telco 4-wire loops.

Each telco loop is connected to a modem that translates electrical signals compatible with telephone equipment into those compatible with computer equipment.
